Scotts Valley Water District

Sequoia Exterior Coating Analysis

Introduction

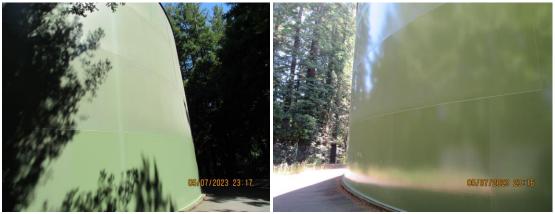
The exterior shell plate coating is in good condition.

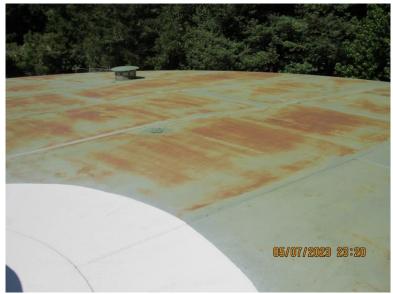
Failed fractured roof plate coating.

The coating failed, and uniform corrosion is coming through the existing roof plate coating.

The roof plate should be abrasive blasted to SSPC/SpNo.10 near white metal. I would recommend wet abrasive blasting using a water ring. All the vents will require protective covers installed each day and removed at the end of the day to prevent the tank from implosion during a rapid drawdown of the rank. The material would to HEPA filter material. A prime coat with a stripe coat of the welds with something like PPG/Ameron Amerlock 2 surface tolerant epoxy. Then a coat of PPG/PSX 700 poly siloxane finish coat. There are better anode covers and the existing covers should be replaced with a rubber handhold grommet which will help with edge corrosion and any water intrusion into the tank. The gap at the interface between the concrete slab and the floor plate extension should be caulked something like Sika 2-C Non sag to prevent water intrusion from entering the bottom of the tank floor plates. The minor areas at the bottom of the tub ring floor plate extension should be touched up with the same system applied to the roof. If you are going to rehabilitate the roof coating system, the outer vents could use new fiber glass covers to protect from water intrusion through the vent screens. The center vent is in good condition.
