**ROBERT W. MILES**  
CONSULTING ENGINEERS

**TECHNICAL MEMORANDUM**

**Date:** May 17, 2023  
**To:** Nate Gillespie, Operations Manager  
**From:** Robert W. Miles  
**Subject:** Scotts Valley Water District  
Bethany Reservoir  
Results of Condition Assessment  
**Engineering** Robert W. Miles, Bob Riley, Ed Darrimon  
**Analysis:**  
**Review:** Ed Darrimon, Bob Riley

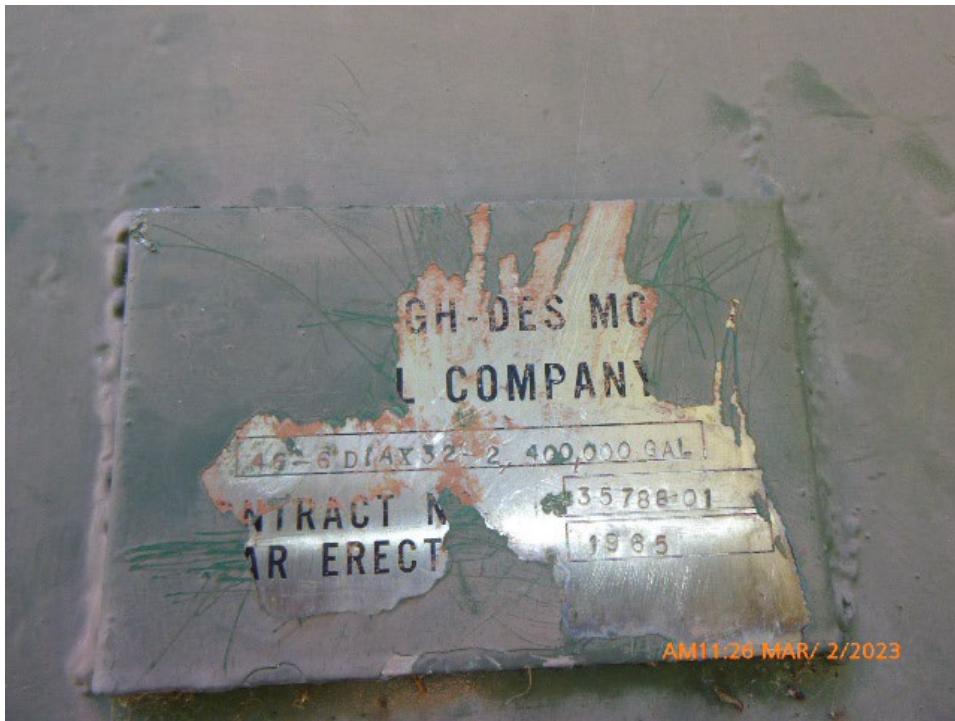
The reservoir was constructed in 1965 by the Pittsburgh-Des Moines Steel Company as recorded on the nameplate. The nameplate (Photo 2) shows a reservoir shell height of 32'-2", a diameter of 46'-6", and capacity of 400,000 gallons, but does not list the American Water Works Association (AWWA) reference standard.

Photo 2 - Nameplate

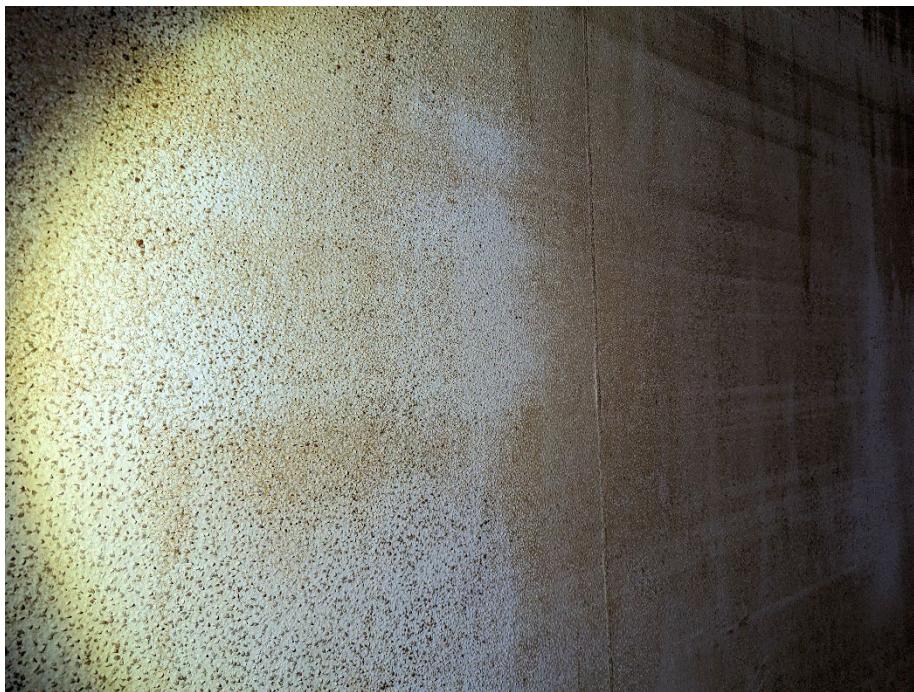
2. The shell plates have developed a uniform pattern of small blisters (Photos 3, 4). The surfaces have developed a white, light, powdery deposit, which is possibly calcium carbonate from the operation of the cathodic protection system protecting steel surfaces beneath fractures of the blisters, or a result of using a zinc orthophosphate sequestering agent in the water. There are only a few small spots that exhibit active corrosion below the operating high-water level. When the existing coating was removed at one location, a smooth, shiny steel surface is visible, indicating that the cathodic protection system is effective. The bottom plates exhibit the same surface condition as the shell plates, but the blister sizes are generally larger (Photo 5). Table 3 summaries dry film thickness measurements for the existing coatings.

Photo 3 – Typical Surfaces of Shell

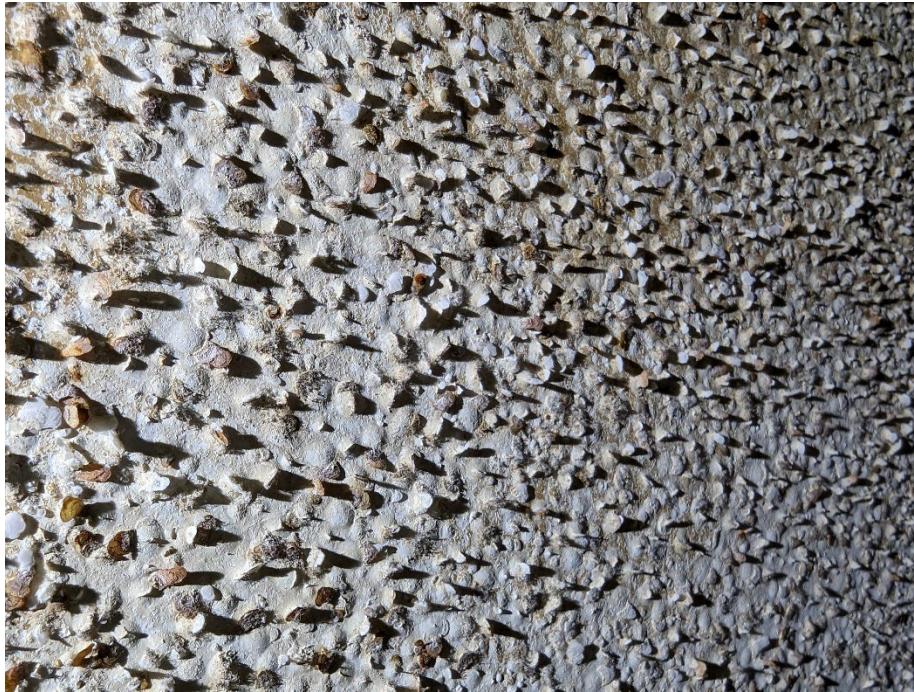
**Photo 4 – Closeup of Shell Coating Blisters**

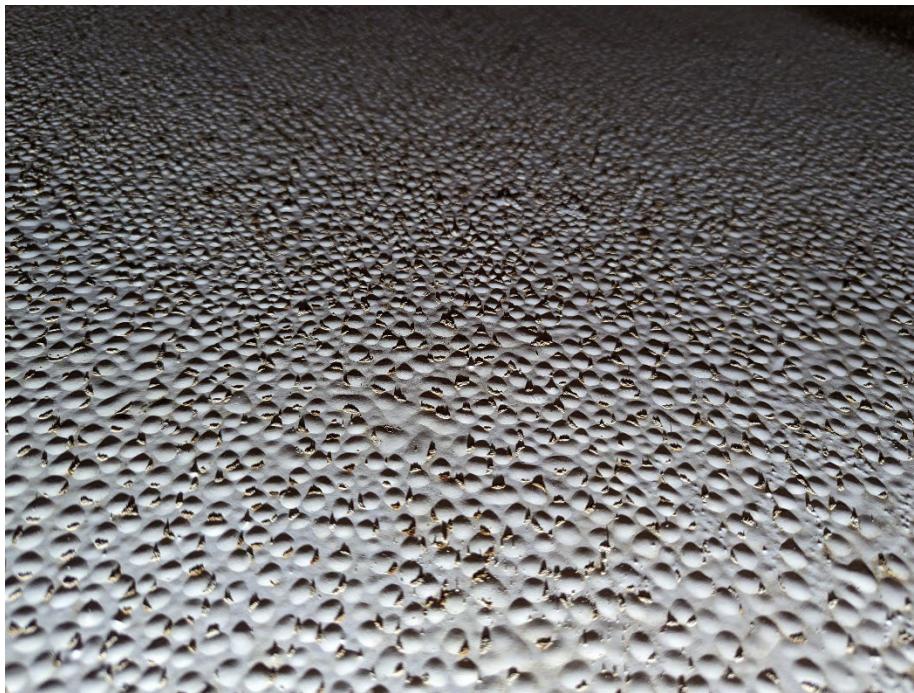
**Photo 5 – Typical Blisters on Bottom Plates**

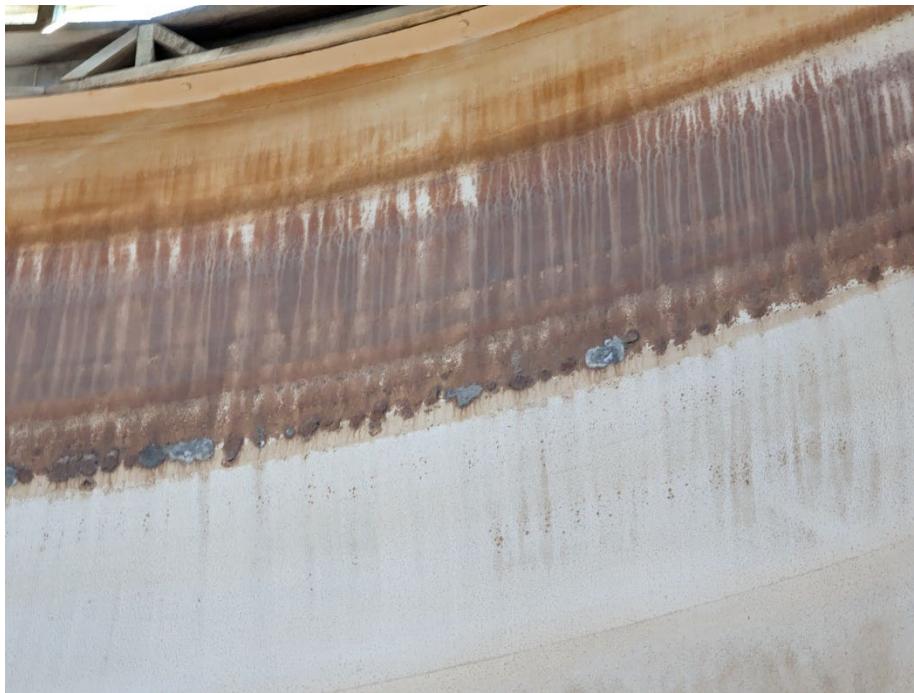
3. At the high-water level, and in the level fluctuation zone near high-water level, the coating system has failed and bare, corroding steel is present (Photos 6, 7). This water level fluctuation zone cannot be protected by the cathodic protection system.

4. The conclusions for the interior coating system immersed surfaces are that the existing vinyl coating system has reached the end of its service life and corrosion protection is being provided only by the cathodic protection system (Reference 13).

**Photo 6 – Coating Failure and Corrosion Above the High-Water Level. Note the corrosion pitting and apparent grey coating patches at the water level.**

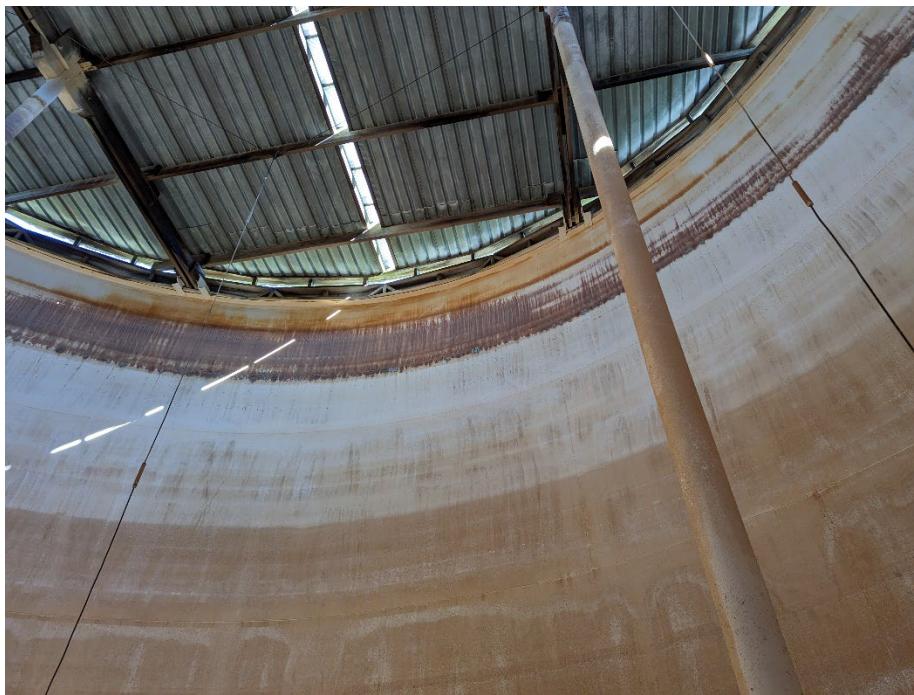
**Photo 7 – Coating Failure and Corrosion Above the Operating Water Level**

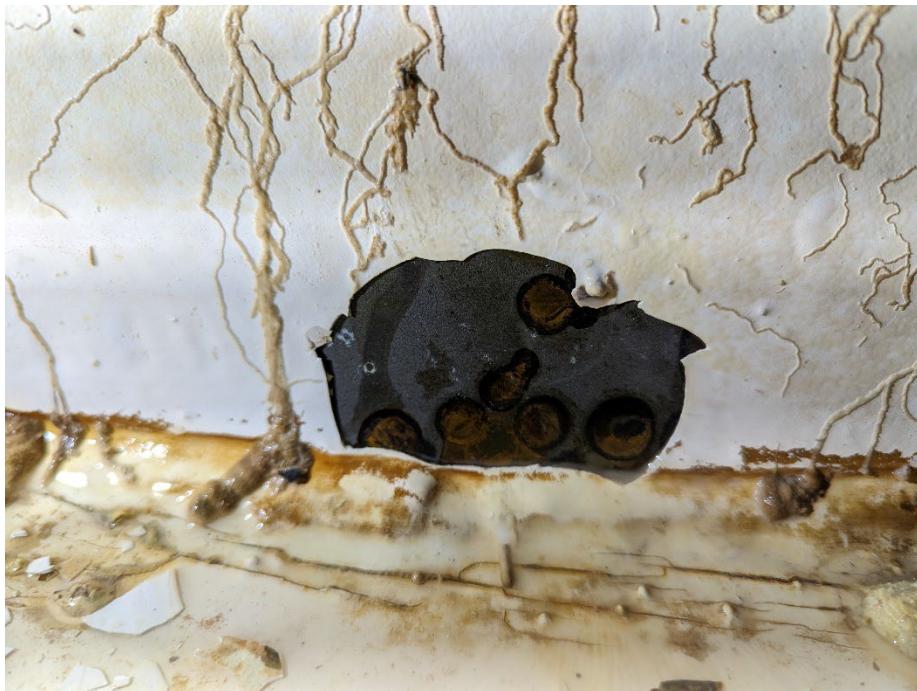
**Photo 8 – Corrosion at Spalled Coating at Base of Shell. Cathodic protection system is limiting the depth of corrosion pits.**

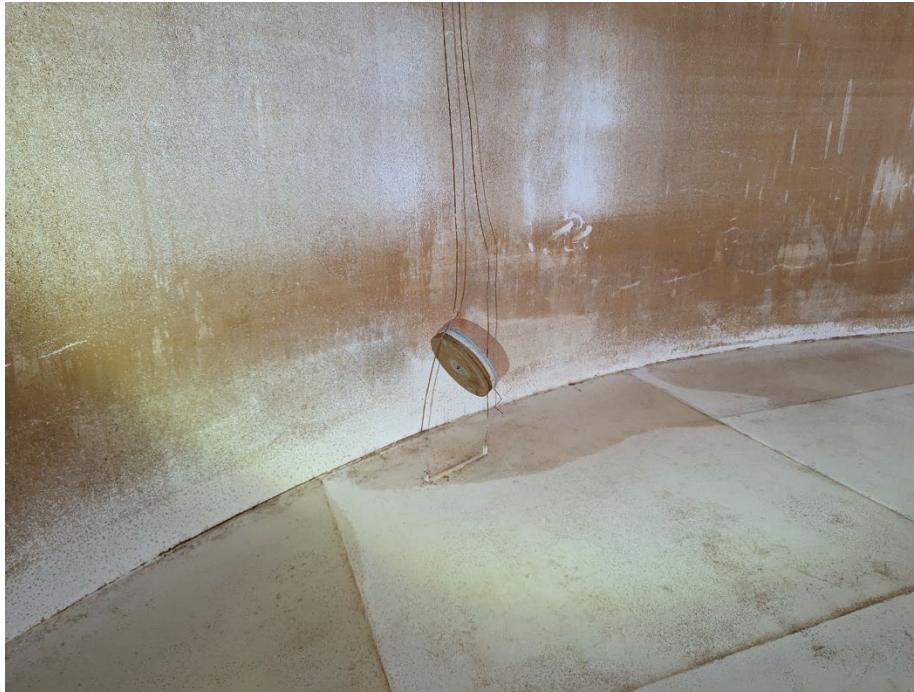
The interior float for the tank gauge has a corroded and separated cable connection and is not operable (Photo 10).

**Photo 10 – Gauge Float Inoperable**

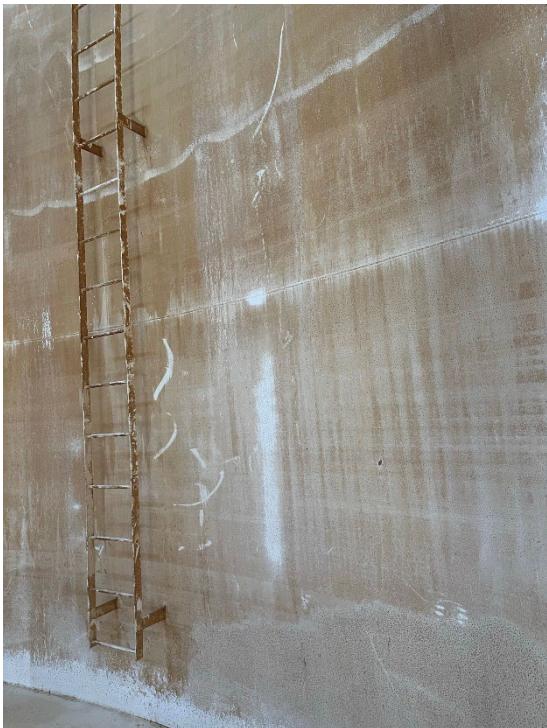
The interior shell ladder (Photos 15, 16) has a width of 16 inches and a rung spacing of 12 inches, and does not have a climbing safety device.

**Photo 15 – Interior Ladder**

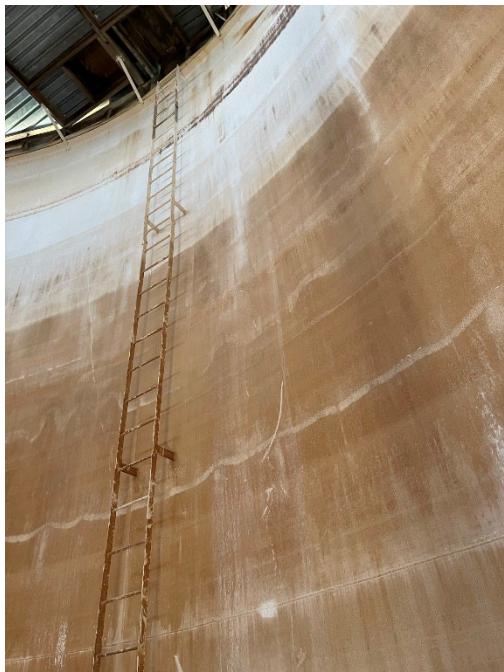
**Photo 16 – Interior Ladder up the shell**

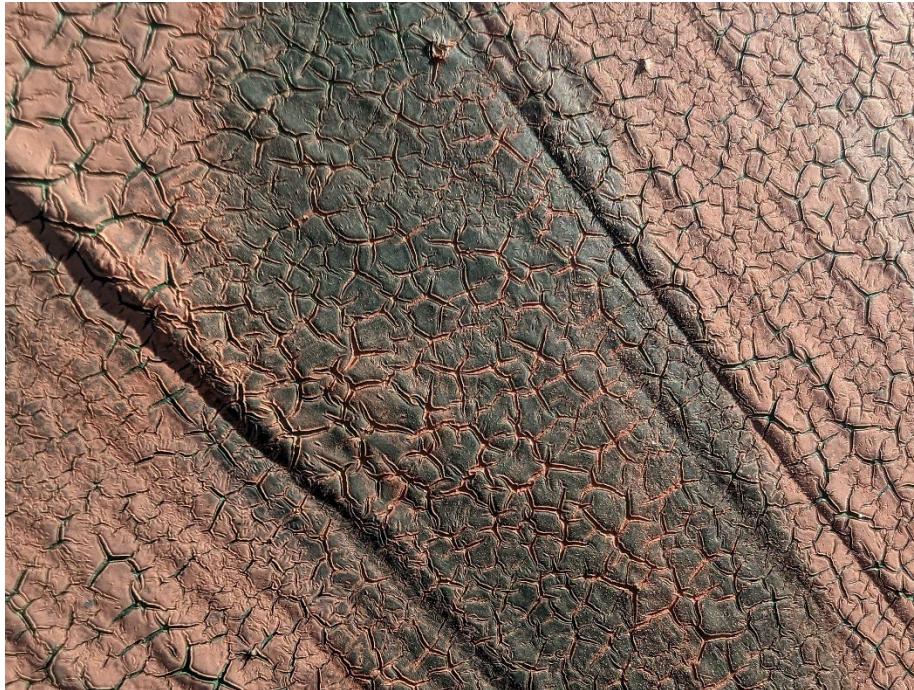
1. The exterior surfaces are characterized by an aged coating system that is still performing well in most areas but has significant areas that have developed a checking type of coating failure (Photo 18). The exterior system is suspected of having a significant lead content, based upon the era in which it was applied. Laboratory testing has been conducted to determine the specific chemical materials in the coating samples, and is attached to this memorandum. The roof top girder/drain gutter has significant corrosion (Photo 19)

**Photo 18 – Closeup of Exterior Checked Coating Failure**

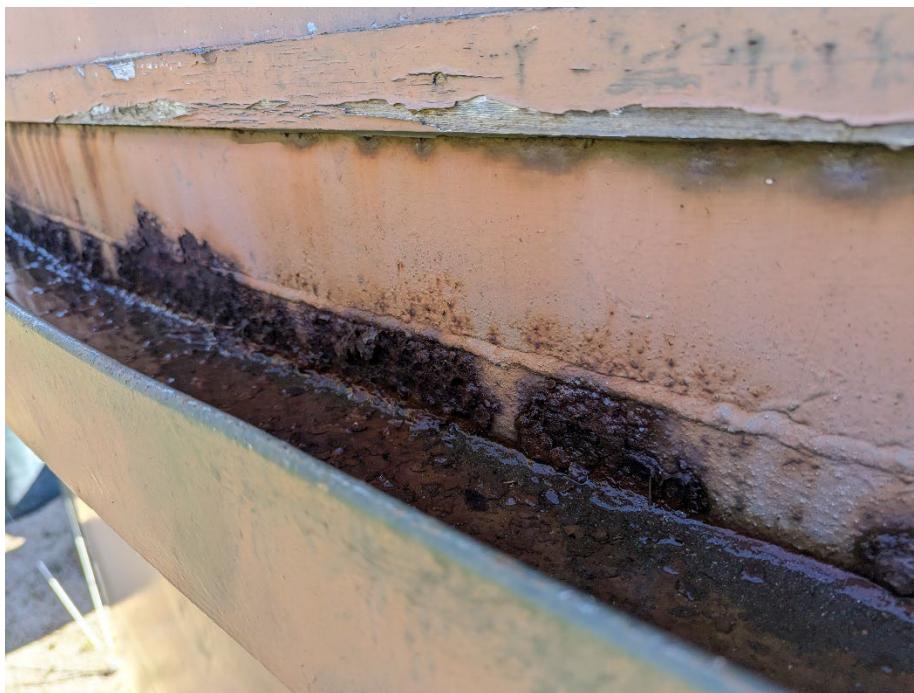
**Photo 19 – Corrosion in the Roof Top Girder/Gutter**

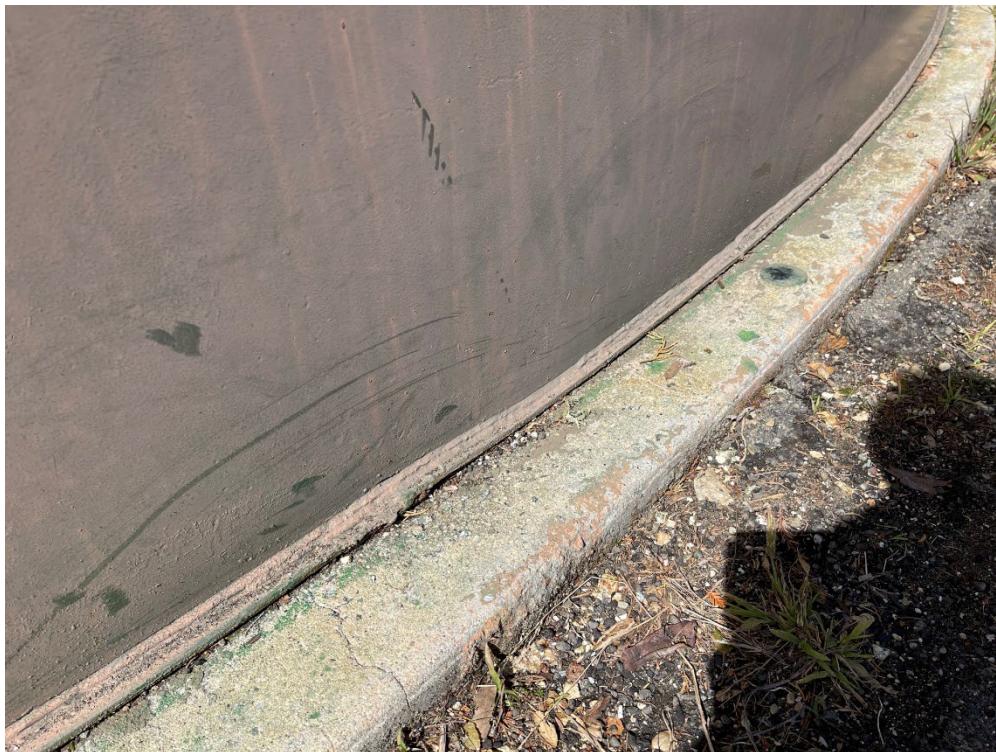
**Photo 20 – Bottom Plate Projection.** In this photo, the bottom plate projection varies greatly from the bottom left to the top right. There appears to be three welding passes in some areas, where only one should have been used.

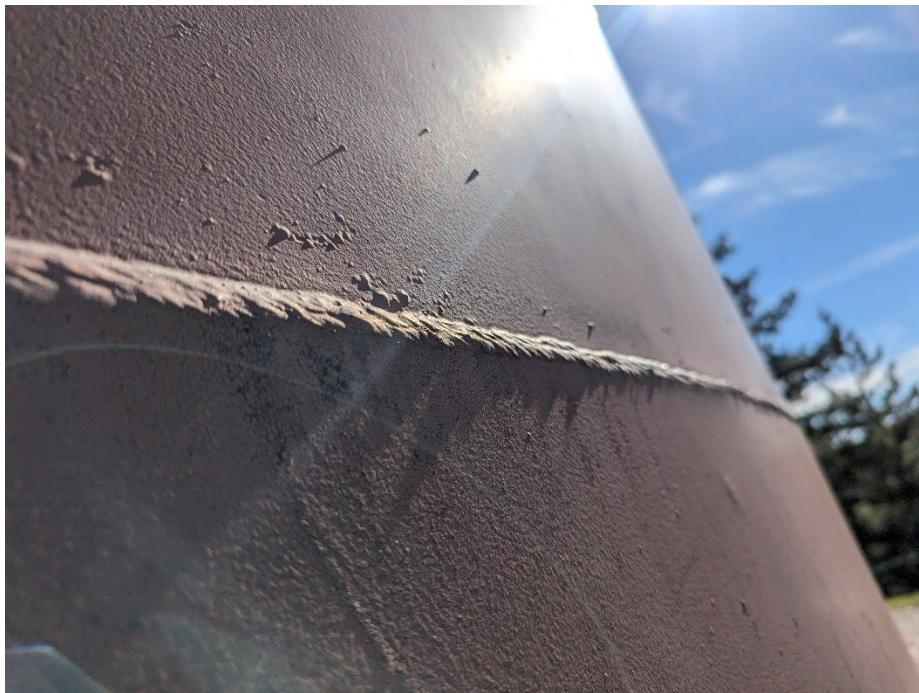
**Photo 21 – Weld Splatter on Horizontal Joint, Ring 1 to Ring 2**

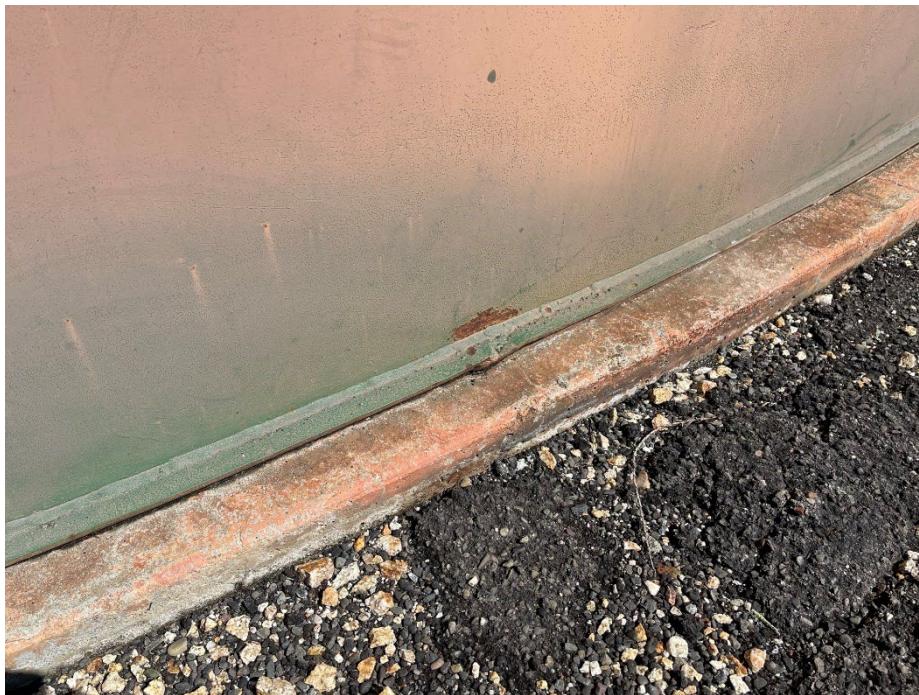
My conclusion at the site was that I had never seen defects like the "bulge" and "dent" that were the results of poor fitting and welding processes. The locations of the dent and weld repairs are in the general azimuth location of the roof cripple wall damage sustained in the Loma Prieta earthquake (Reference 4). In view of the coincidental locations of the bulge, dent, and past damage to the roof, it is probable that the bulge and dent represent incipient shell buckling damage caused by the earthquake.

**Photo 22 – Weld Repair at Shell to Bottom Joint**

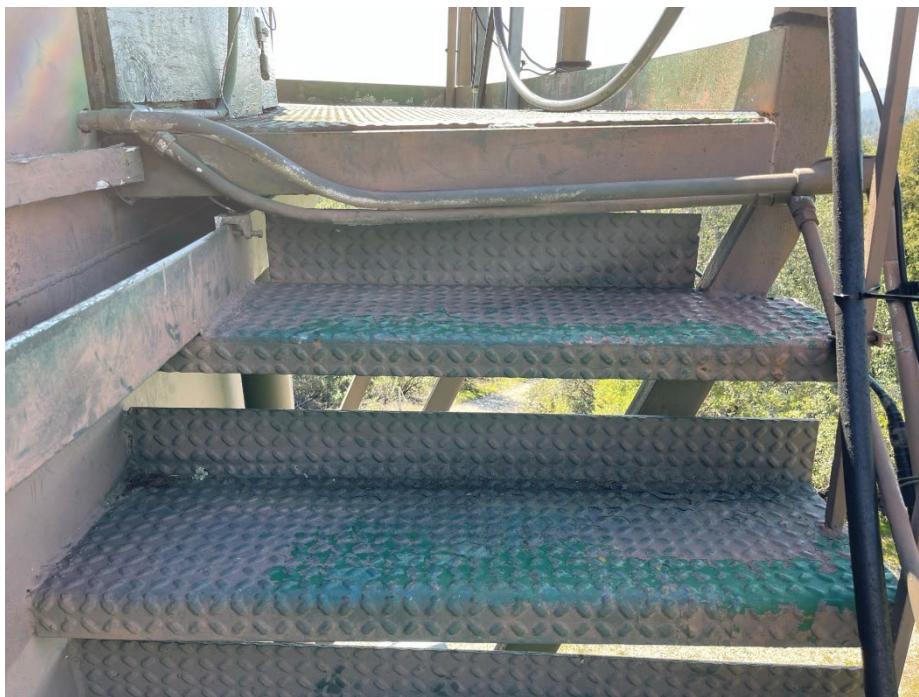
1. The treads are less than the required 10-inch depth, but a factor that magnifies this deficiency is that there is a toe board at the rear of each tread (Photos 23, 24) that prevents placement of the worker's boot securely onto the tread. If the worker has a boot size of about 12 or larger, there is no space for the heel on the tread. This forces the worker to traverse the stairway sideways, to obtain space for the heel of the boot.

**Photo 23 – Stairway Tread. Note the toe board at the back of the treads.**

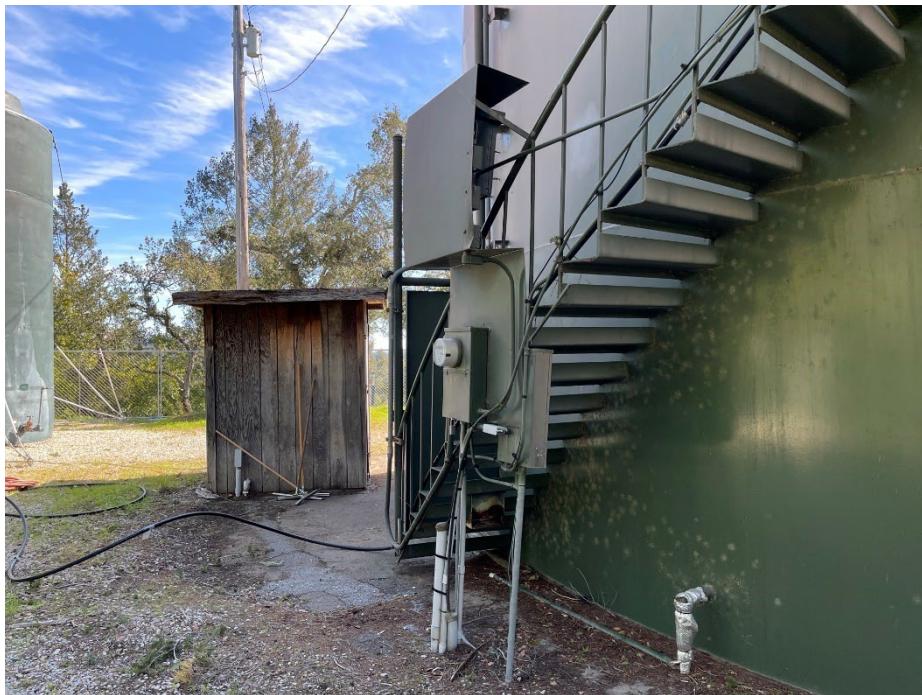
2. Treads are placed so that there is no overlap of each tread face over the rear face of the tread immediately below (Photo 24). This is related to Item 1 above.

**Photo 24 – Rear View of Stairway. Note the lack of overlap between treads and presence of a toe board at rear of each tread.**

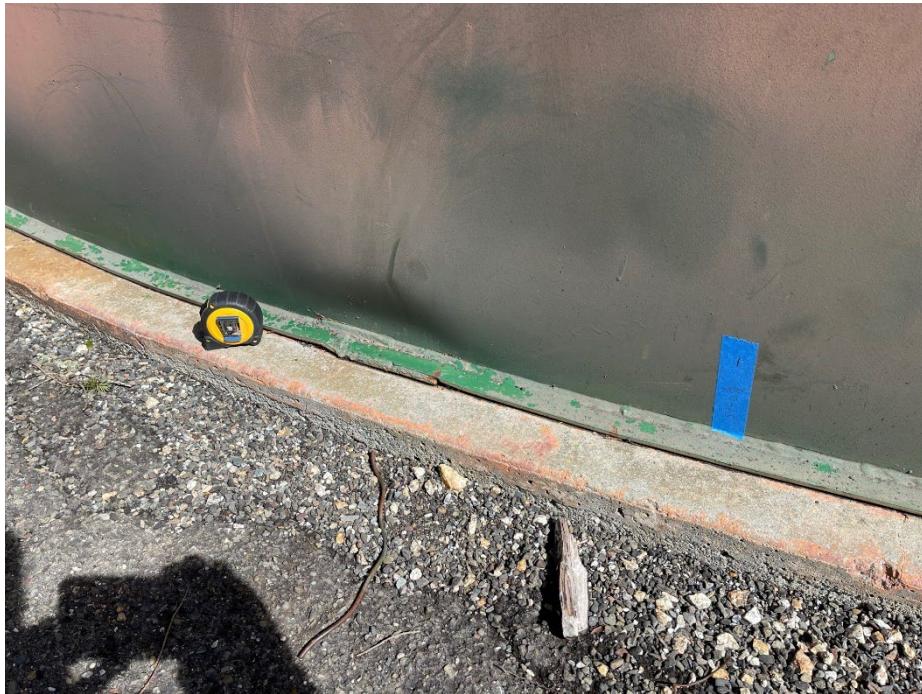
During the assessment, a "dent" was observed in the shell, at the entrance road side of the reservoir (Photo 25). The dent is where the shell crosses over a fillet-welded joint in the bottom plates. It is located at about azimuth 225 degrees, as measured by the phone compass application. Near the dent there are several weld repairs on the shell-to-bottom weld, and each of these is where the shell passes over a lap joint in the bottom (Photo 22). There is also a small shell "bulge" on the opposite side near the stairway, at about azimuth 32 degrees. It is also at the location of a bottom lap joint. Although relatively easy to feel by hand, efforts to obtain a clear photo of the bulge area were not successful due to the lighting conditions. These areas are about 180 to 190 degrees apart. It may be that these areas represent damage from rocking motion during the Loma Prieta earthquake.

**Photo 25 – "Dent" at Shell to Bottom Joint**

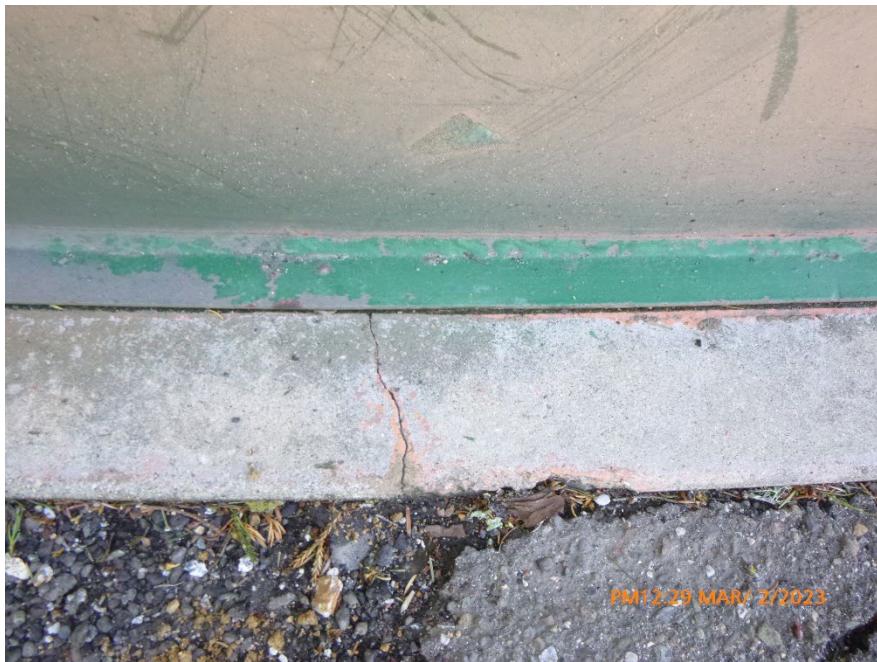
A visual review of the concrete ringwall foundation indicated that the concrete appears to be in generally sound and undamaged condition. There are radial cracks that may have formed as the result of drying shrinkage of the concrete following placement in 1965 (Photos 27, 28). The ringwall was excavated at one location (Photos 29, 30), indicating that the ringwall is about 12 inches in depth.

**Photo 27 – Radial Crack in Concrete Foundation**

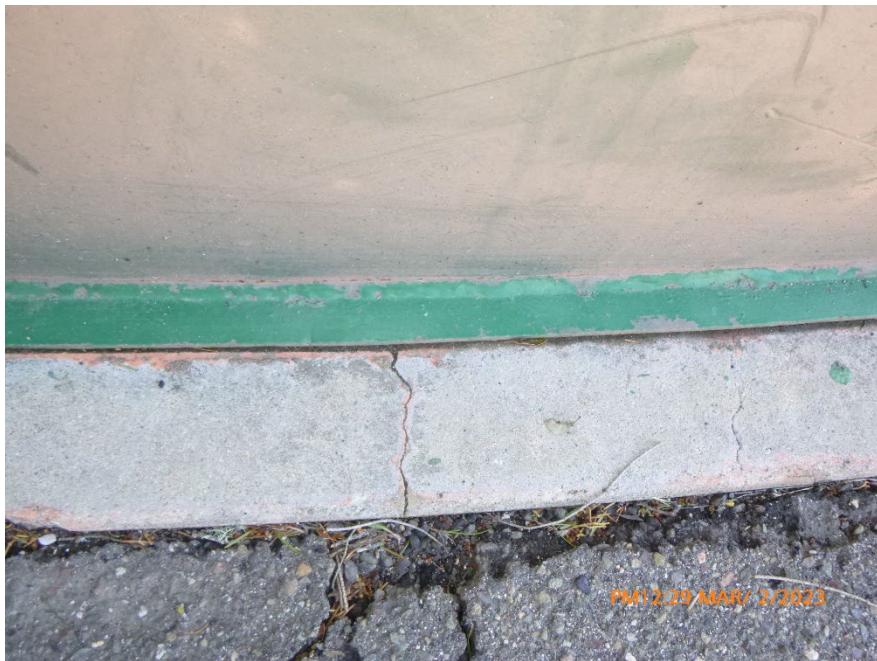
**Photo 28 – Radial Cracks in Concrete Foundation. There are two cracks in this photo.**

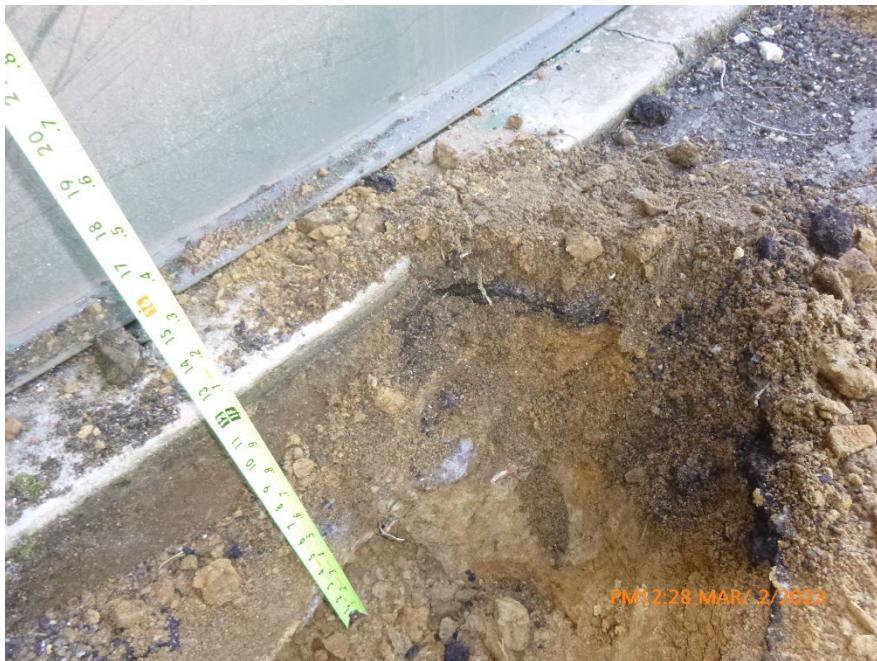
**Photo 30 – Foundation Appears to Be About 12 inches In Depth**
