Mr. David McNair  
Operations Manager  
Scotts Valley Water District  
2 Civic Center Drive  
Scotts Valley, CA 95066

M.E. Simpson Co., Inc. is pleased to submit this report of our leak detection survey for the Scotts Valley Water District. This survey addressed the Scotts Valley water distribution system, consisting of approximately 63.5 miles of water main. The report contains the results of our investigation including the following:

## LEAK LOCATION REPORT

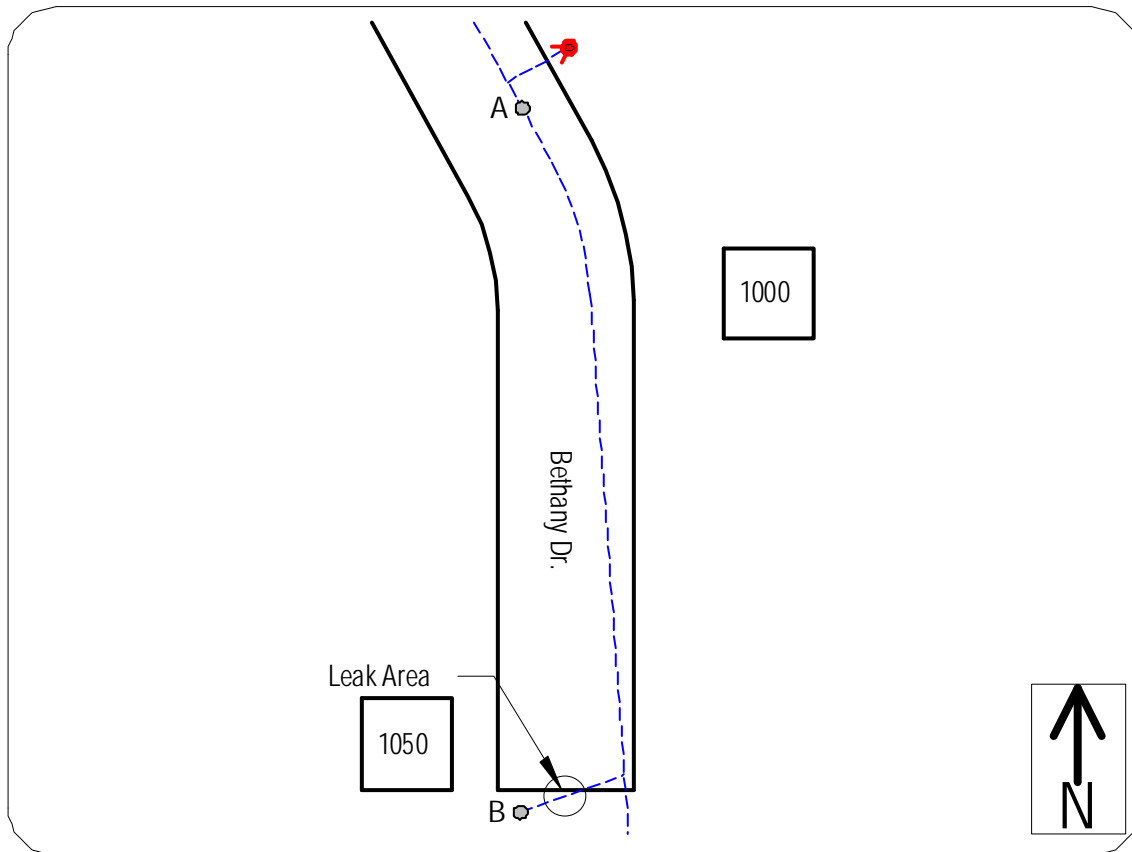
**Address:** 1000 Bethany Drive

**Distance:** 169' from A to B

**Connection point:** A= Main Line Valve

**Connection point:** B= Blow-Off Valve

**Leak Location:** 8' from B

**Comments:** We used a ground microphone to survey the area and the loudest noise is at a stub tee. We suggest digging at this point.

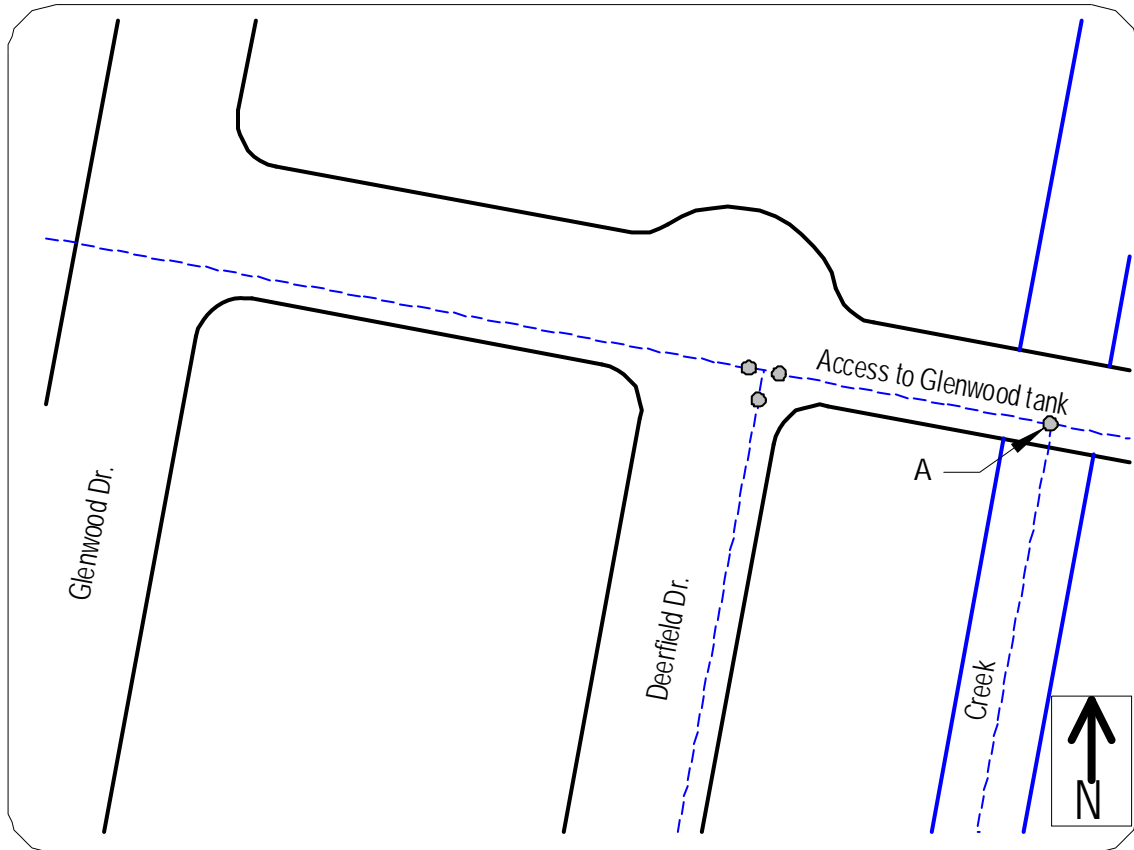
**Address:** Glenwood Drive & Deerfield Drive

**Distance:** 0' from A

**Connection point:** A= Main Line Stub Valve

**Leak Location:** 0' from A

**Comments:** This was a leak on a main line stub valve. The valve was screaming and we could hear it when we walked up to the valve box. We could visibly see water coming out of the stub valve. Dan from the water department came out and closed the valve and the leak noise quit and the water stopped. This leak is fixed.

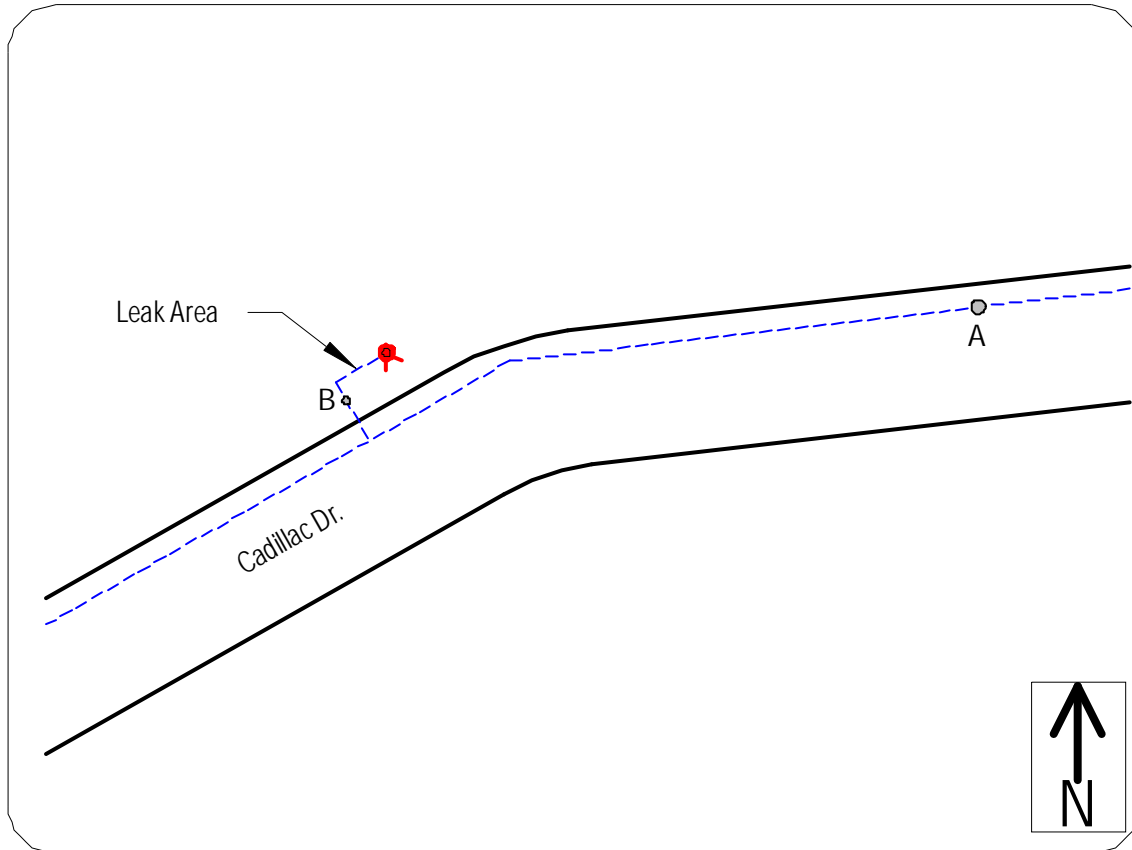
**Address:** 712 Cadillac Drive

**Distance:** 146' from A to B / 10' from B to C

**Connection point:** A= Main Line Valve

**Connection point:** B= Hydrant Auxiliary Valve

**Connection point:** C= Hydrant

**Leak Location:** 5' from B

**Comments:** We correlated from "A" to "B" and it comes up 0' from "B". We correlated from "B" to "C" and it comes up 5' from "B". We suggest digging up at the 90 degree angle on the hydrant leg.
