M.E. Simpson Co., Inc. is pleased to submit this report of our leak detection survey for the Scotts Valley Water District. This survey addressed the Scotts Valley water distribution system, consisting of approximately 63.5 miles of water main. The report contains the results of our investigation including the following:

LEAK LOCATION REPORT

Client: Scotts Valley, California

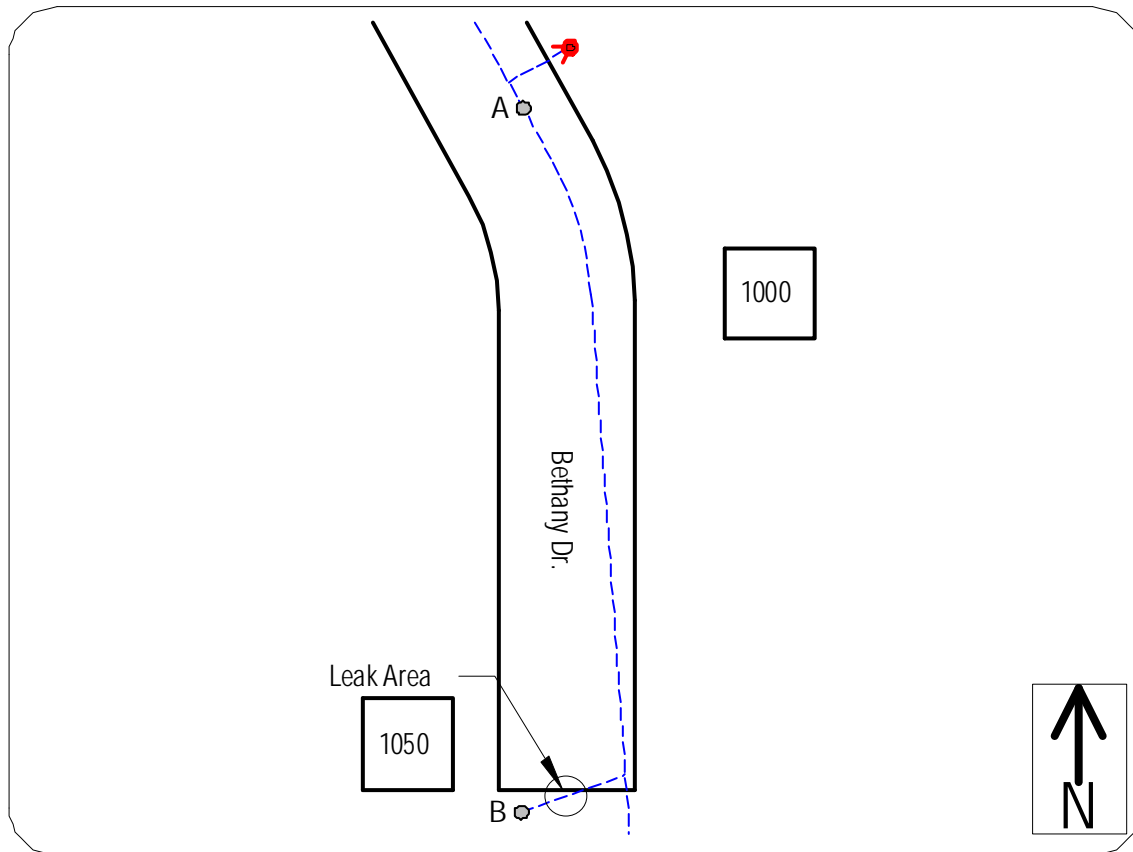
Address: 1000 Bethany Drive

Distance: 169' from A to B

Connection point: A= Main Line Valve

Connection point: B= Blow-Off Valve

Leak Location: 8' from B

Comments: We used a ground microphone to survey the area and the loudest noise is at a stub tee. We suggest digging at this point.

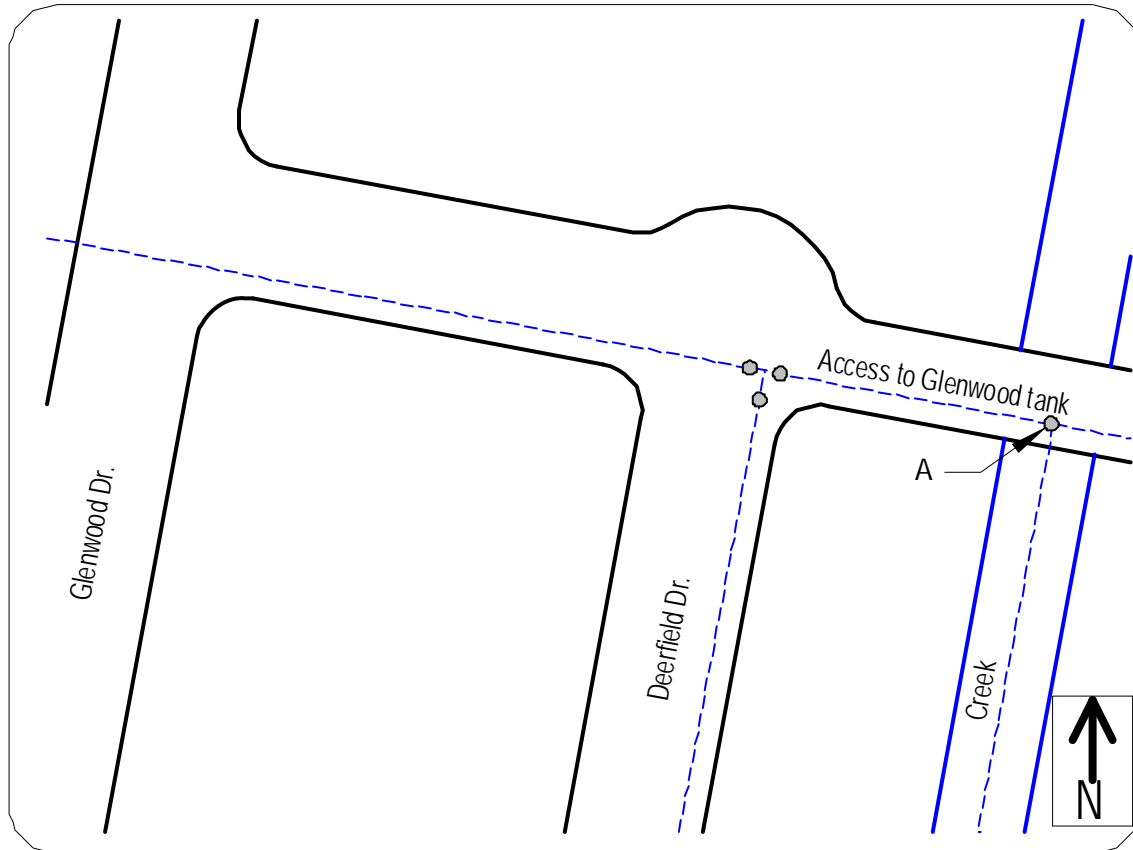
Address: Glenwood Drive & Deerfield Drive

Distance: 0' from A

Connection point: A= Main Line Stub Valve

Leak Location: 0' from A

Comments: This was a leak on a main line stub valve. The valve was screaming and we could hear it when we walked up to the valve box. We could visibly see water coming out of the stub valve. Dan from the water department came out and closed the valve and the leak noise quit and the water stopped. This leak is fixed.
