GEOTECHNICAL INVESTIGATION

BETHANY WATER TANK REPLACEMENT
SCOTTS VALLEY, CALIFORNIA

Subject: **Geotechnical Investigation – Design Phase**
Bethany Tank Replacement
Scotts Valley, California

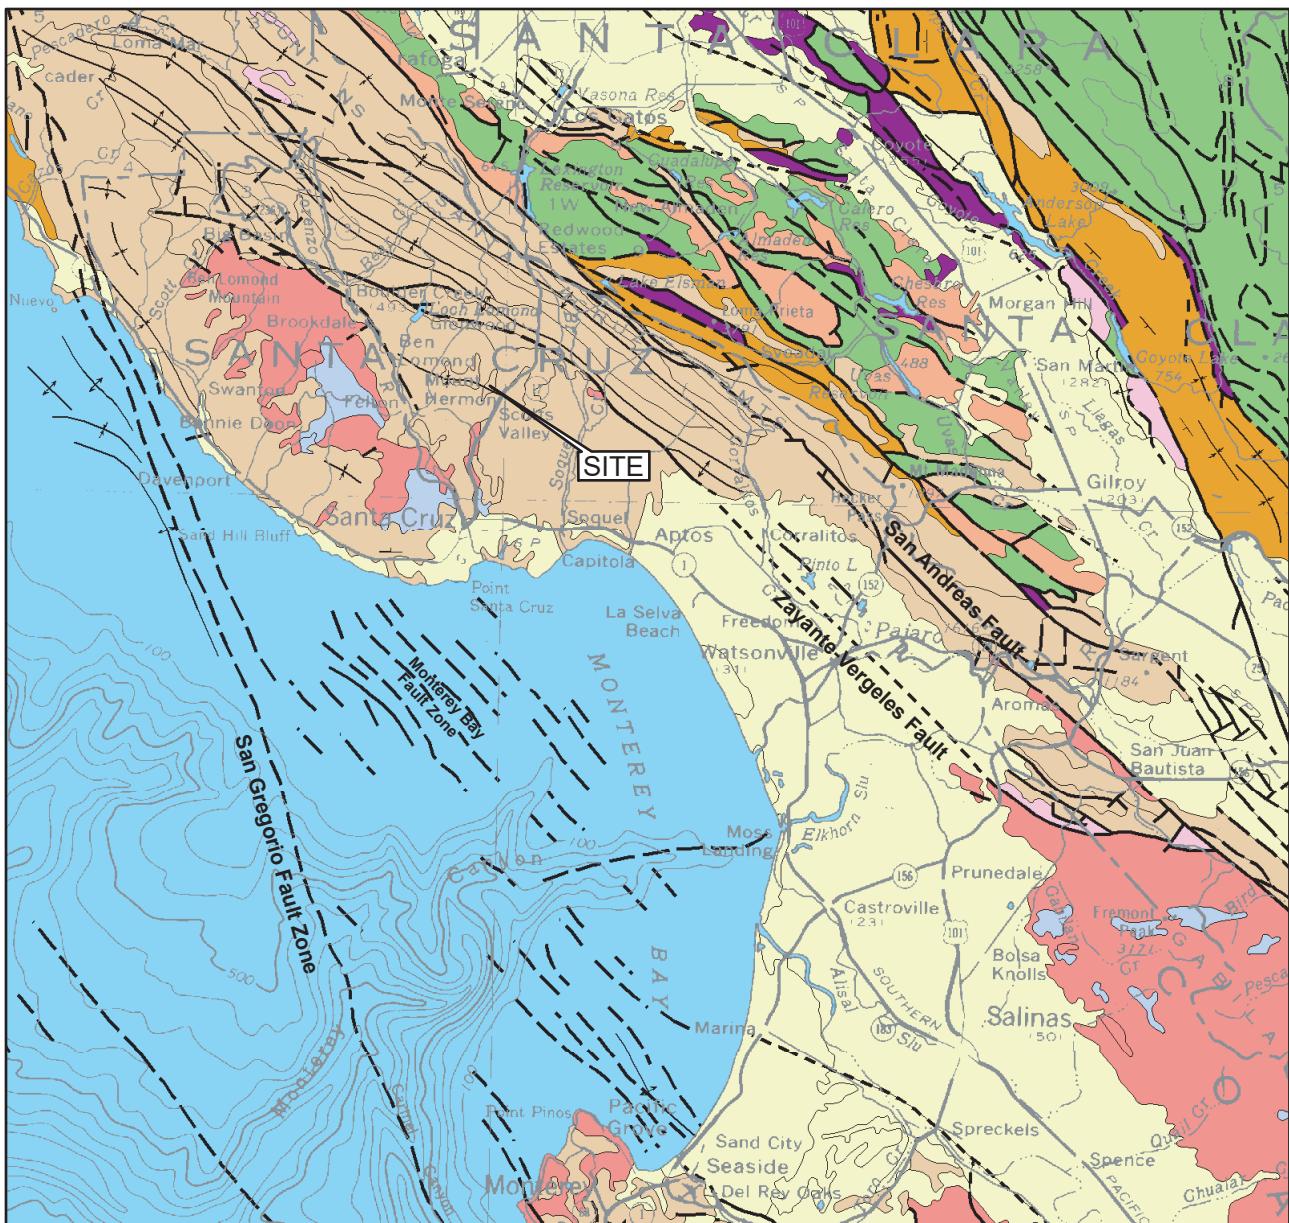
FIGURE #
2
JOB #
24069

Regional Geologic Map
Bethany Tank Replacement
Scotts Valley
California

The subject property lies on a narrow bedrock ridge crest in the Santa Cruz Mountains in the central Coast Ranges physiographic province of California. This portion of the Coast Ranges is formed by a series of rugged, linear ridges and valleys following the pronounced northwest to southeast structural grain of central California geology. The Santa Cruz Mountains are mostly underlain by a large, elongate prism of granitic and metamorphic basement rocks, known collectively as the Salinian Block. These rocks are separated from contrasting basement rock types to the northeast by the San Andreas fault and to the southwest by the Sur-Nacimiento-San Gregorio fault system. Overlying the granitic basement rocks is a sequence of dominantly marine sedimentary rocks of Paleocene to Pliocene age and non-marine sediments of Pliocene to Pleistocene age (Figure 2).

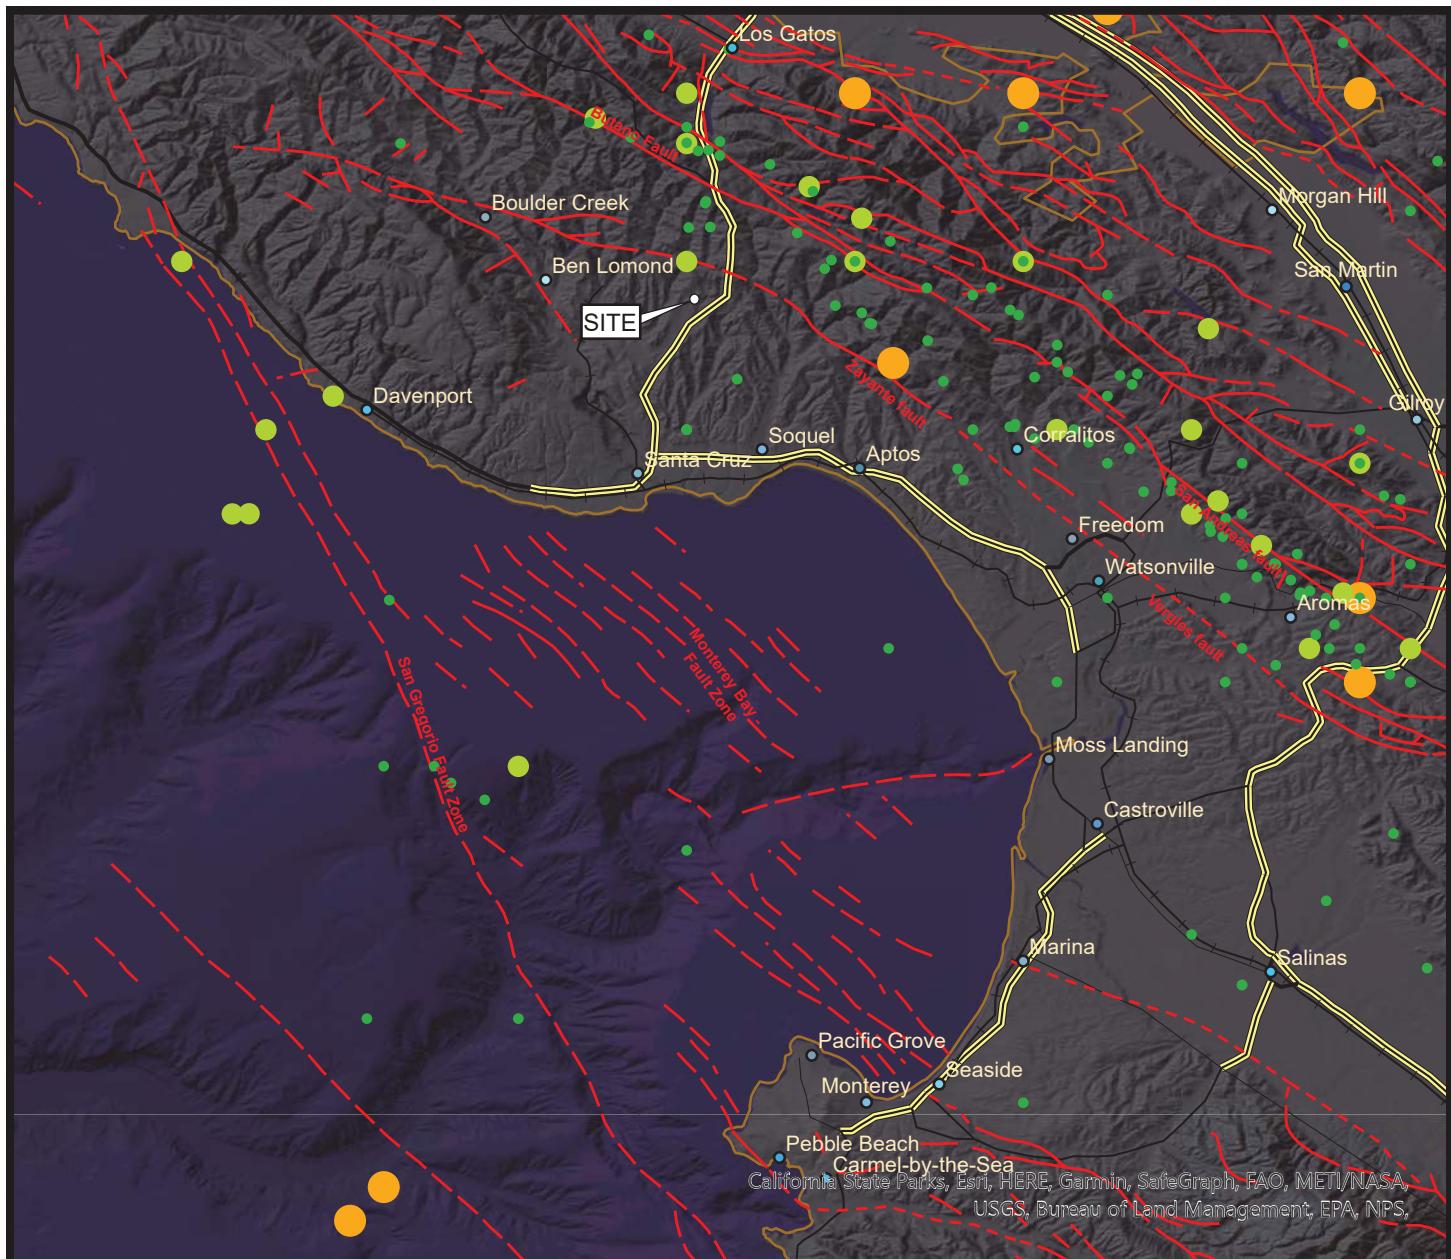
FIGURE #
3
JOB #
24069

Seismicity Information: Magnitude 4 and greater earthquakes, compiled from various sources, 1769 to 2000; available at www.consrv.ca.gov/CGS/rghm/quakes/cgs2000_fnl.txt

Regional Seismicity Map
Bethany Tank Replacement
Scotts Valley
California

California's broad system of strike-slip faulting has had a long and complex history. Some of these faults present a seismic hazard to the subject property. The most important of these are the San Andreas and Zayante(-Vergeles) fault zones (Figures 2 and 3). These faults are either active or considered potentially active (Hall et al., 1974; Petersen et al., 1996; Working Group On Northern California Earthquake Potential [WGONCEP], 1996).

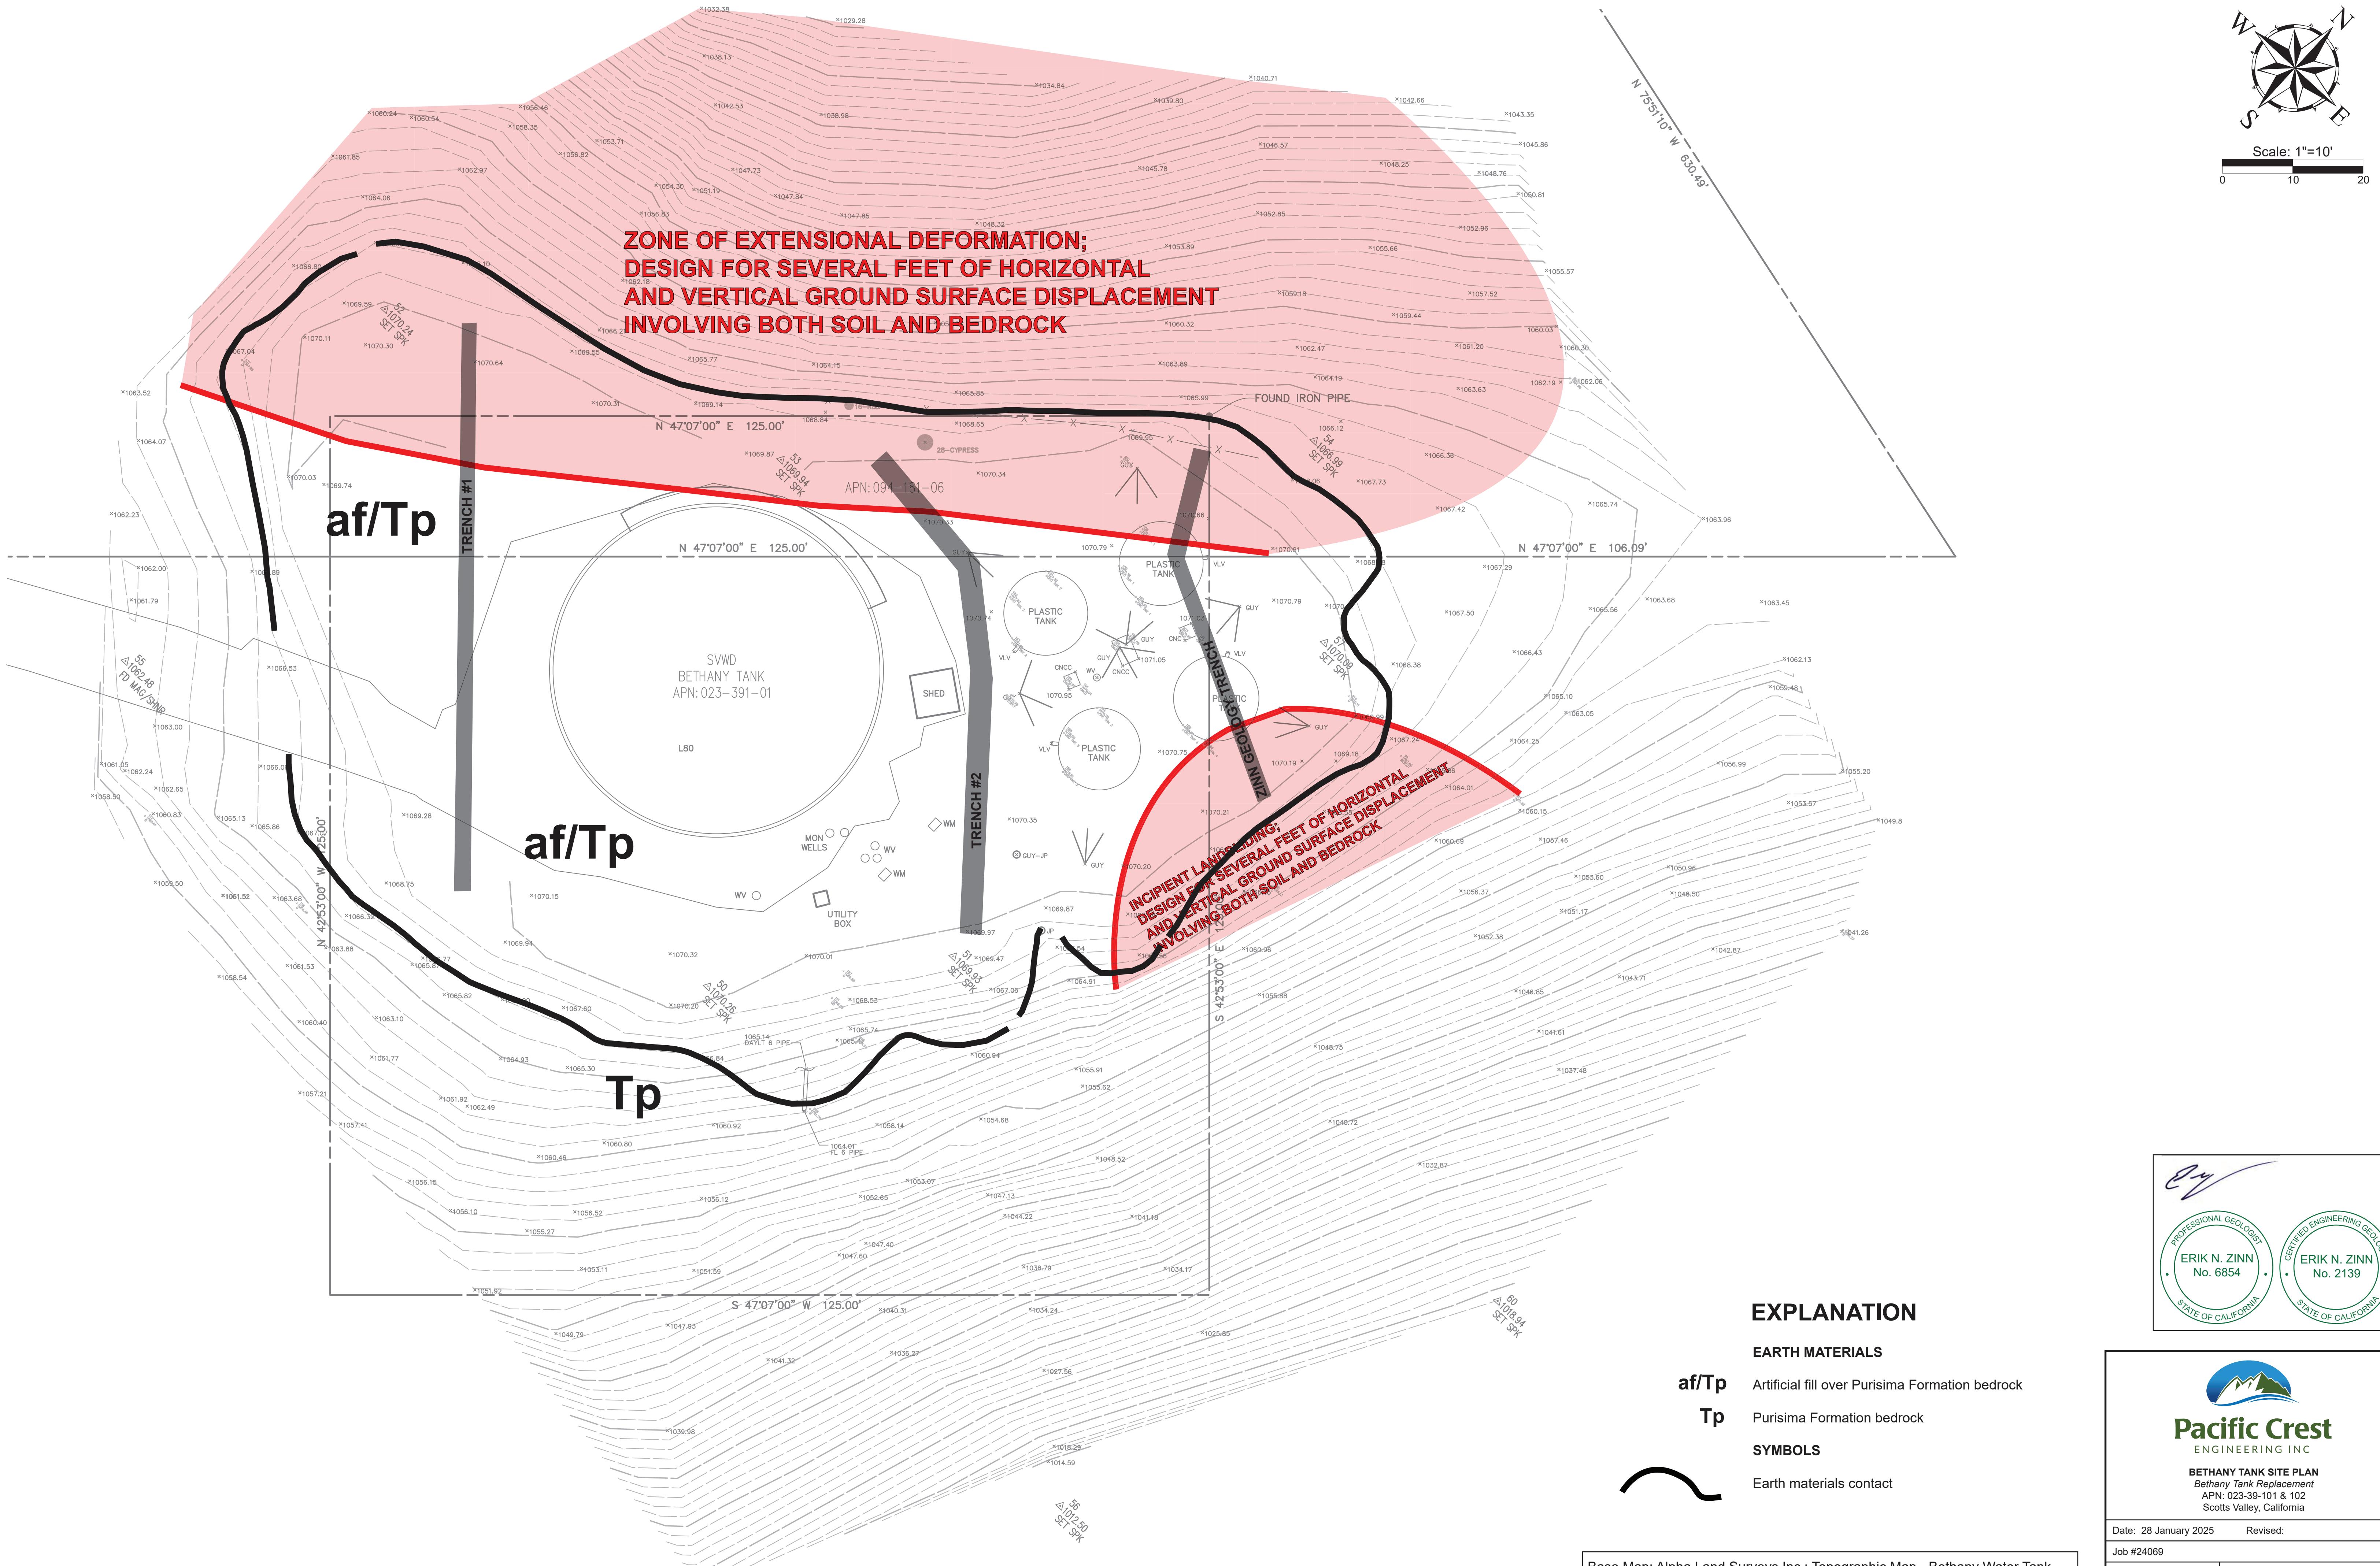
EXPLANATION

EARTH MATERIALS

This letter summarizes the results of our supplemental trenching and geological investigation program for proposed tank replacement for the Bethany Tank, located approximately 600 feet east of the northern terminus of Tabor Drive in Scotts Valley, California. The site is a graded pad situated on a very narrow bedrock ridge (see Figure 1 and Plate 1).

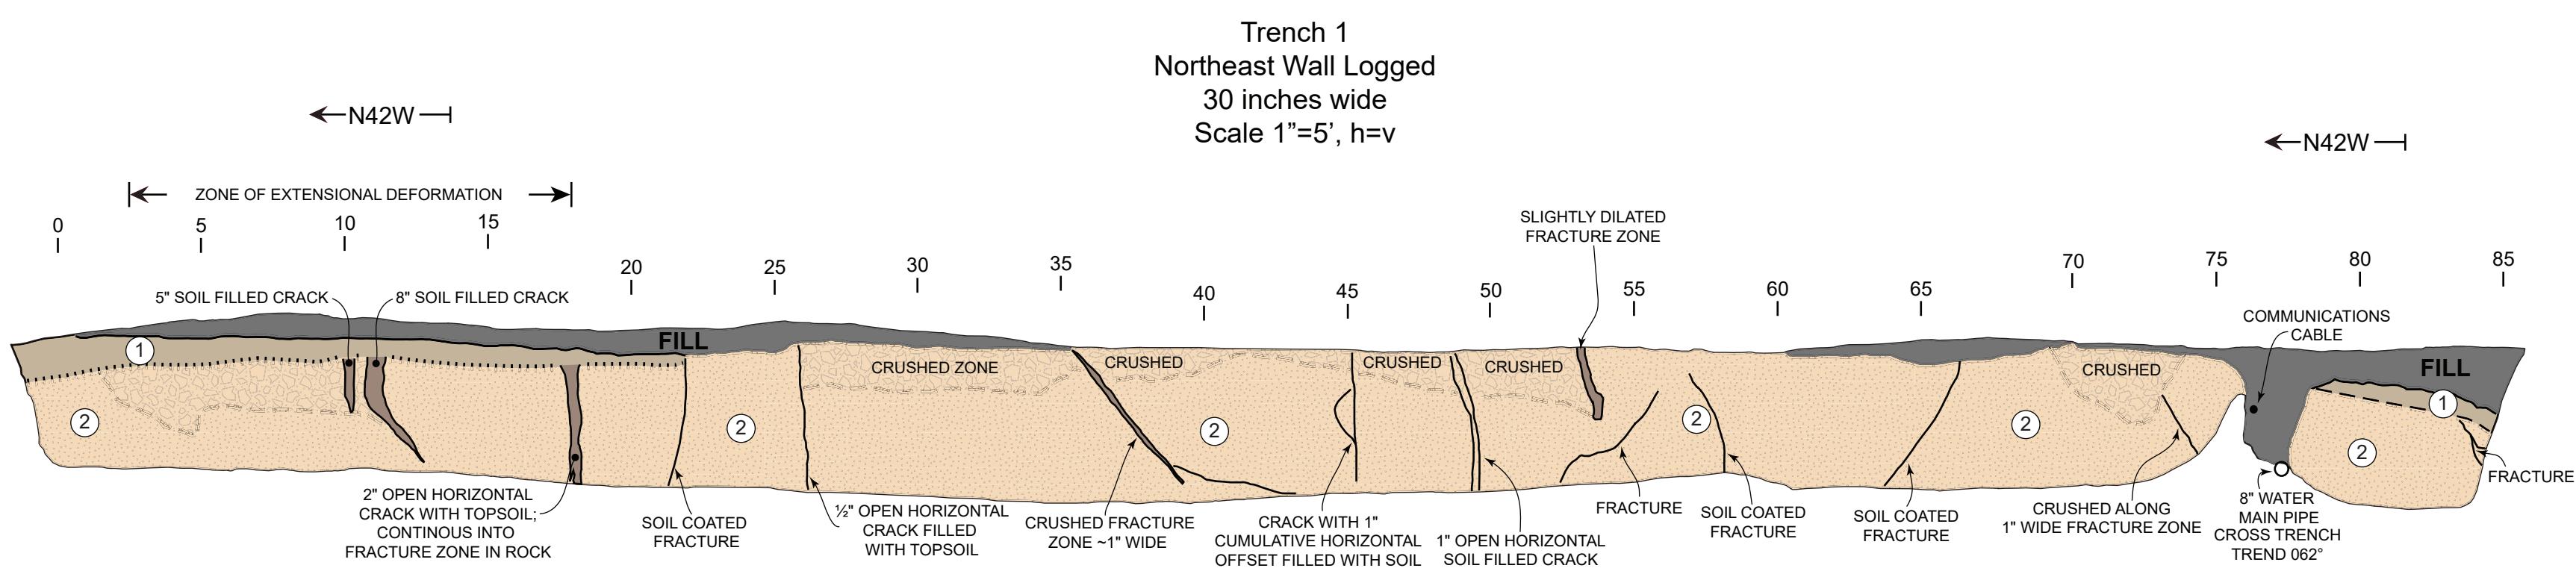
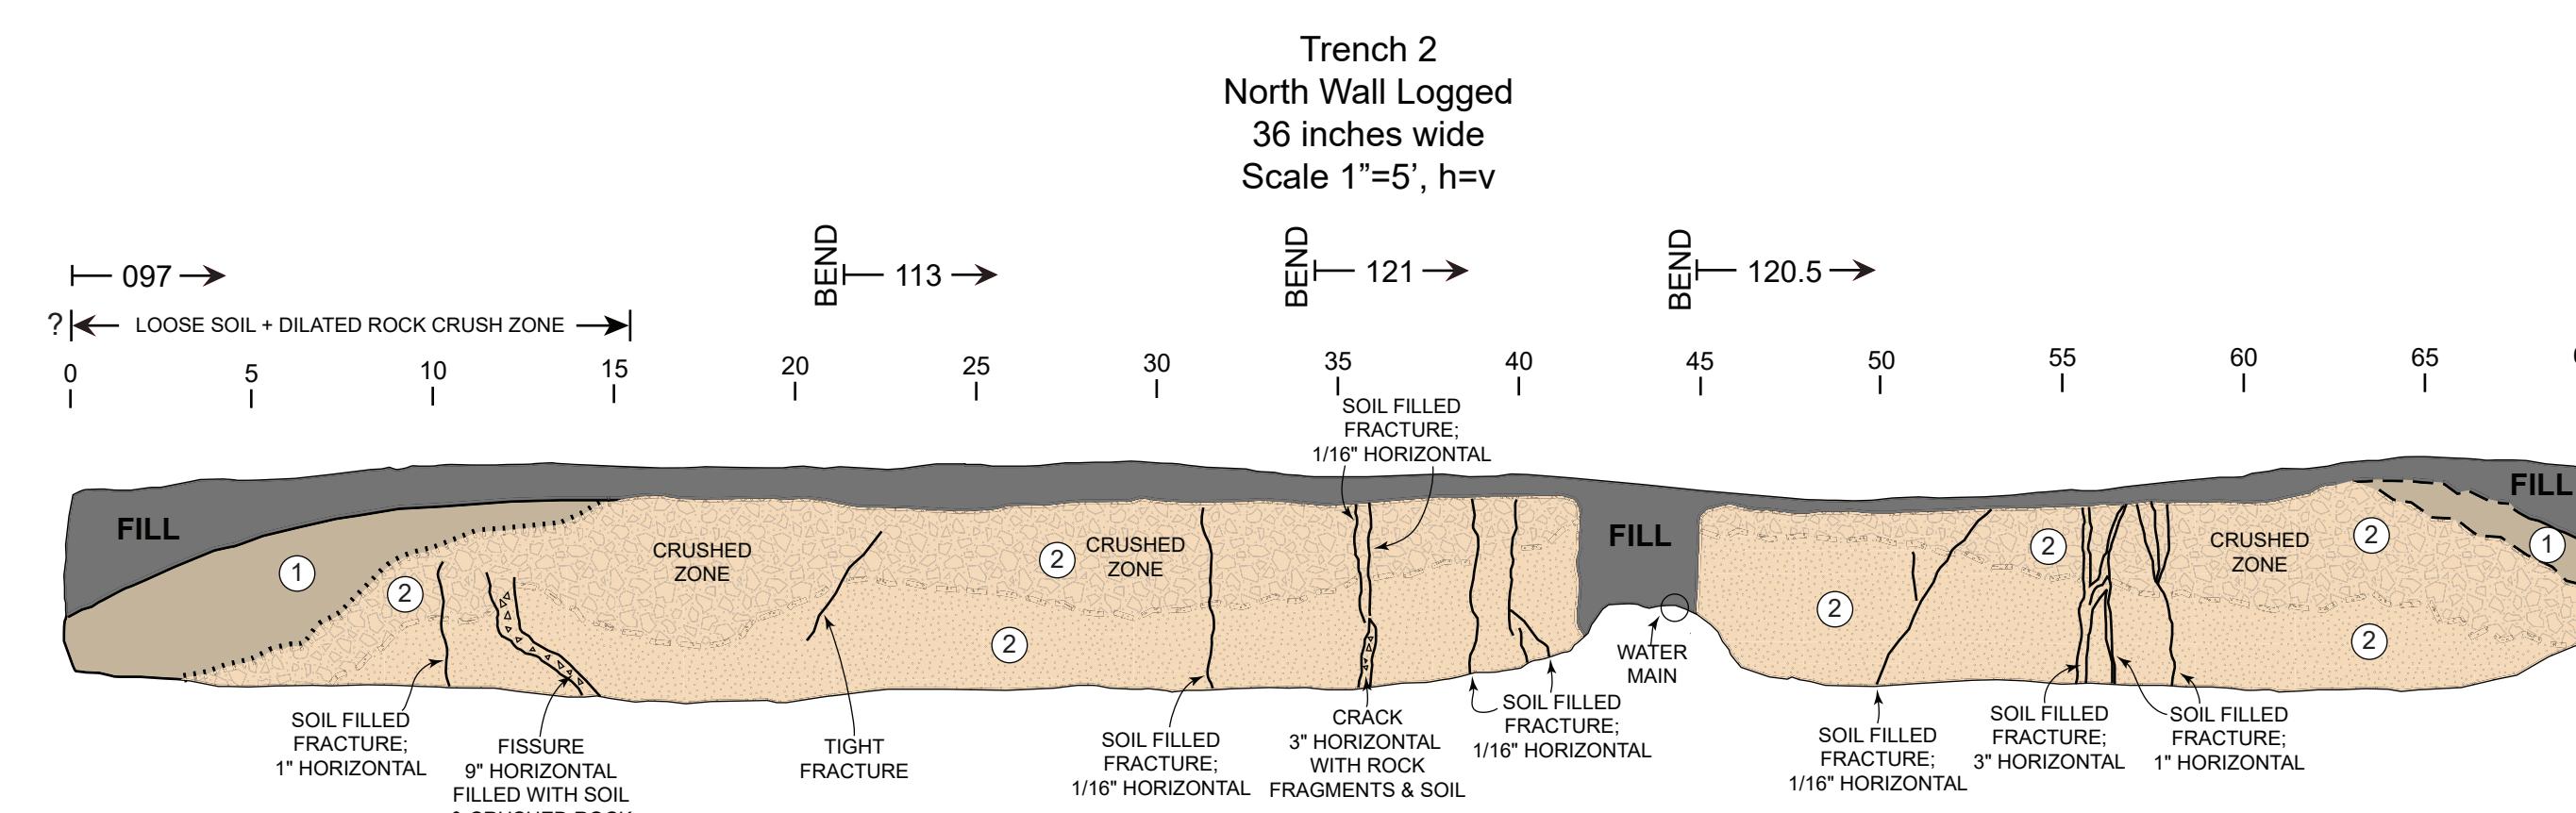
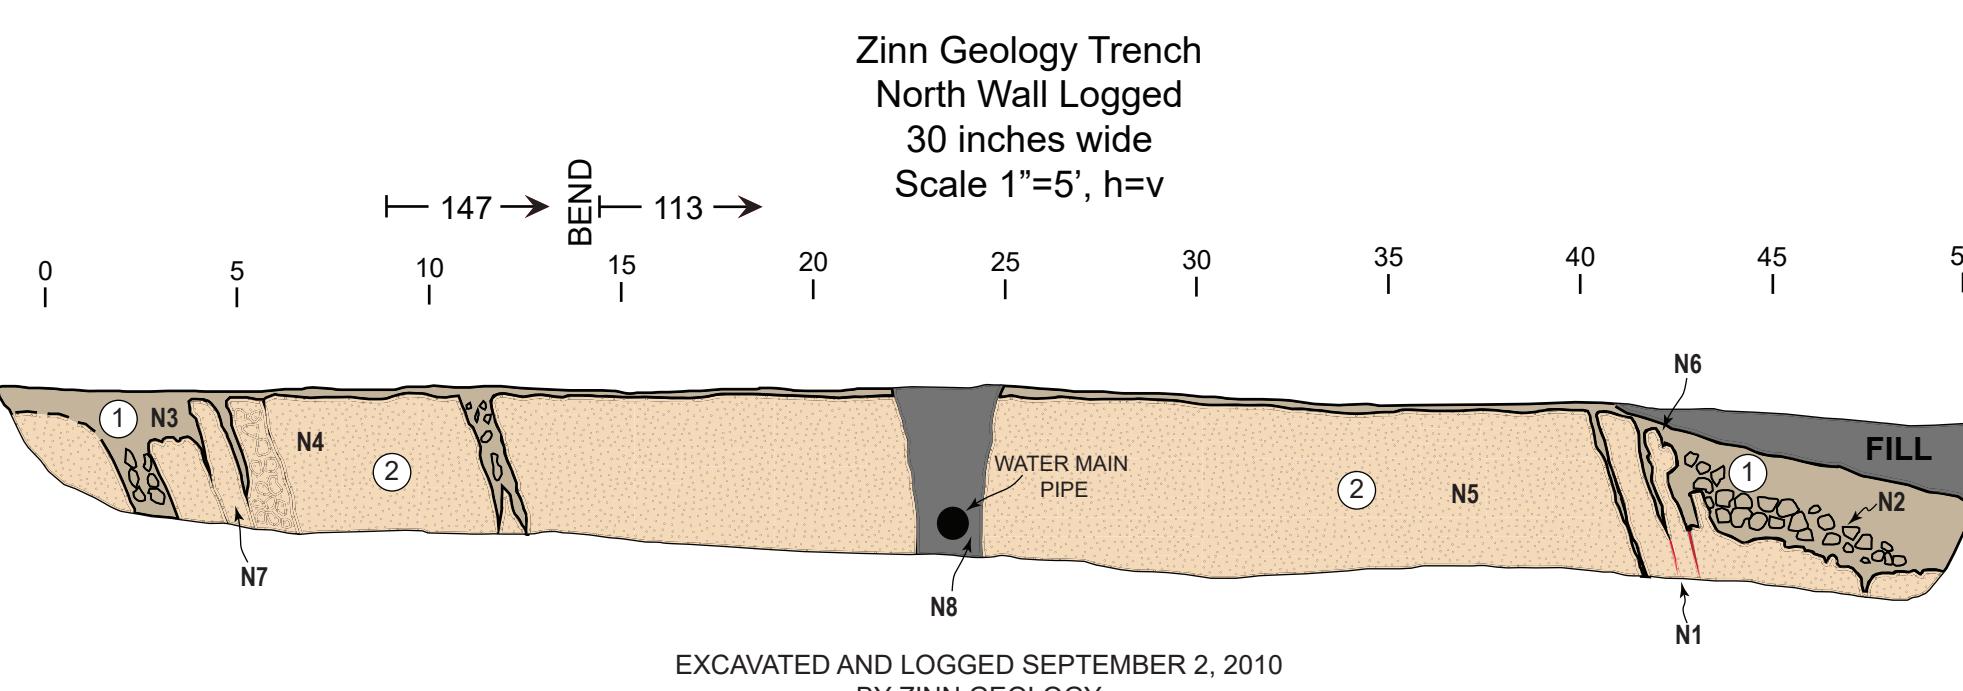
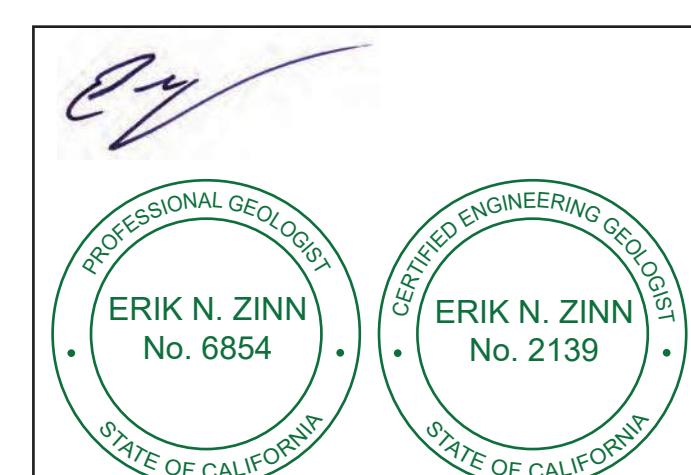
EXPLANATION

TRENCH UNIT DESCRIPTIONS:

NOTES

N1 Landslide formed along extensional cracking, might have occurred in one event, at least 2 1/2' to 3' of vertical separation, cumulative horizontal offset is approximately 1' separation in this zone
 N2 Stone line from collapsed rock face
 N3 Open fracture zone, approximately 1' of vertical offset with approximately 1' horizontal cumulative offset
 N4 Open fracture zone, no measurable vertical offset, approximately 1' horizontal separation
 N5 Fracture: 150/77° SW
 N6 Escarpment cross-trench: 022/85-90°
 N7 Fracture: 208/78° E
 N8 190° is cross-trench trend for water pipe main

The proposed tank site sits atop a bedrock ridge that is clearly cut by coseismic ground cracking related to ridge-top spreading occurring from the center out (see Plate 2). In our opinion significant coseismic ground cracks, with at least 2 inches of horizontal and vertical displacement, are likely to affect the proposed tank site within its design life. This corresponds to a greater than lowest possible risk as outlined in the risk tables in Appendix B. The risk with respect to ground cracking should be mitigated and reduced to the lowest possible risk level through a combination of tank placement and foundation design to accommodate the anticipated coseismic ground cracking.
